Conductor Bar in EMS-Systems

Program 0811

1 Collector Unit

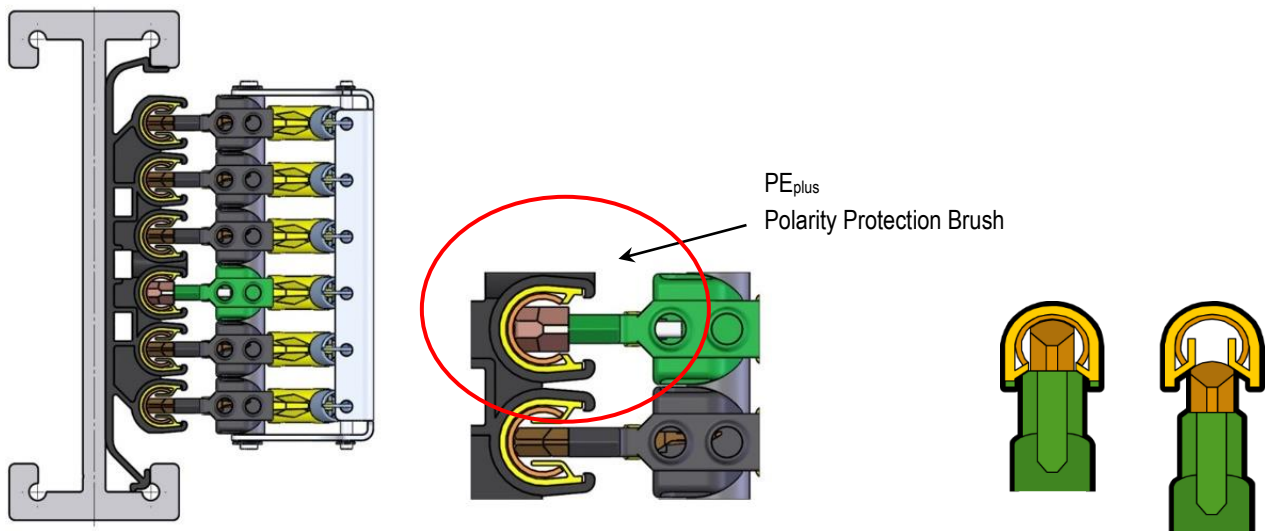
Fig. 1: Polarity Protection PE_{plus}

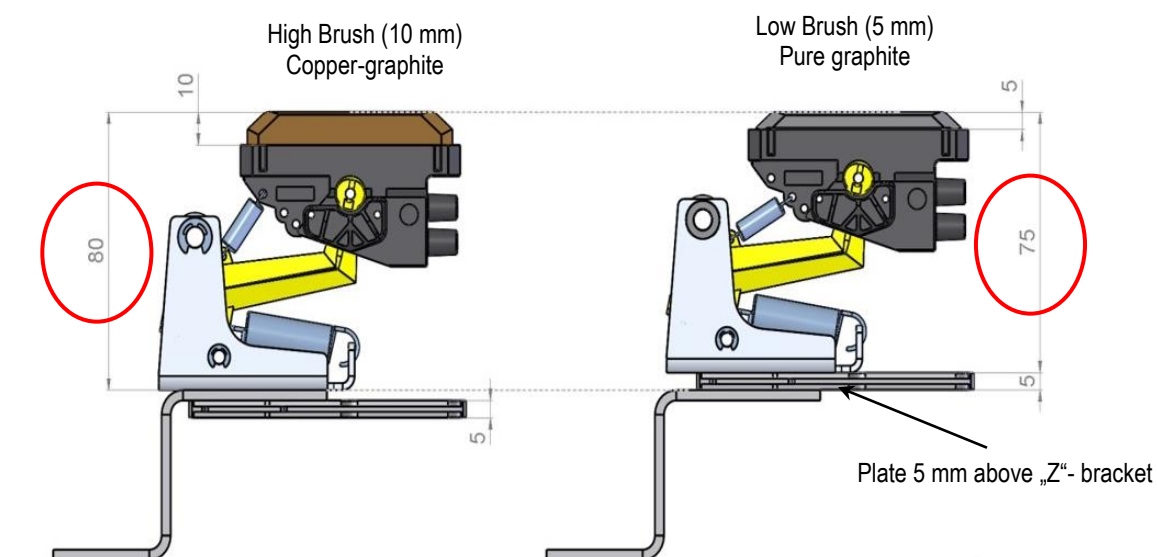
Fig. 2: Comparison of collectors with copper-graphite brushes and pure graphite brushes

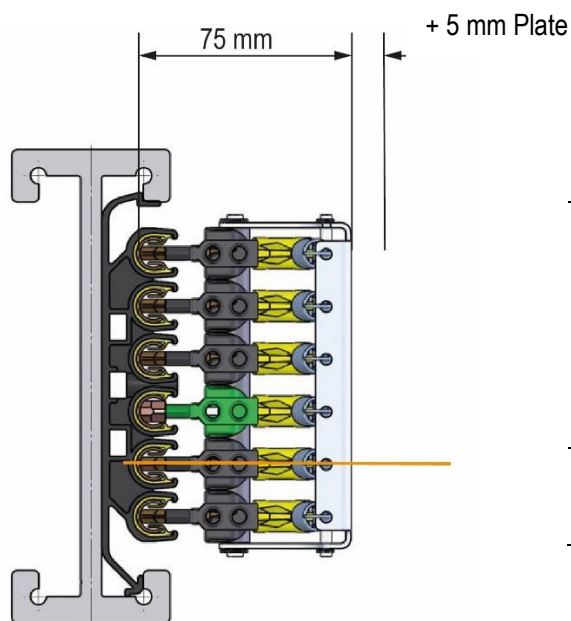
1. Old copper- graphite collector height (when engaged): 80 mm (due to brush head with 10 mm height).
New pure graphite collector height (when engaged): 75 mm (due to brush head with 5 mm height)
Plate 5 mm must be used
2. Collector adjustment: Exact center line of copper rail and brush head to be kept

Fig. 4: Replace copper-graphite Collectors with pure graphite Collectors

BMW stipulates a plate with a cable guide 08-P025-0191-001. This plate must be considered for new installations and rebuilding. It allows the obeying of the correct installation dimensions and a safe cable guide.

For EMS applications which are not used for BMW we also recommend to retrofit the plate according to the distance dimension of 75 mm.

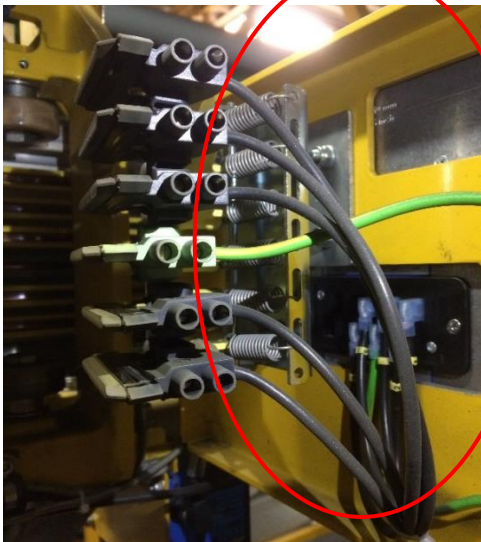
Fig. 5: Cables which are not installed correctly

1. Cables are not installed correctly:
 - No parallel cable guide
 - Cable bundle creates force on collector heads
 - Collector heads are not running parallel to conductor rail

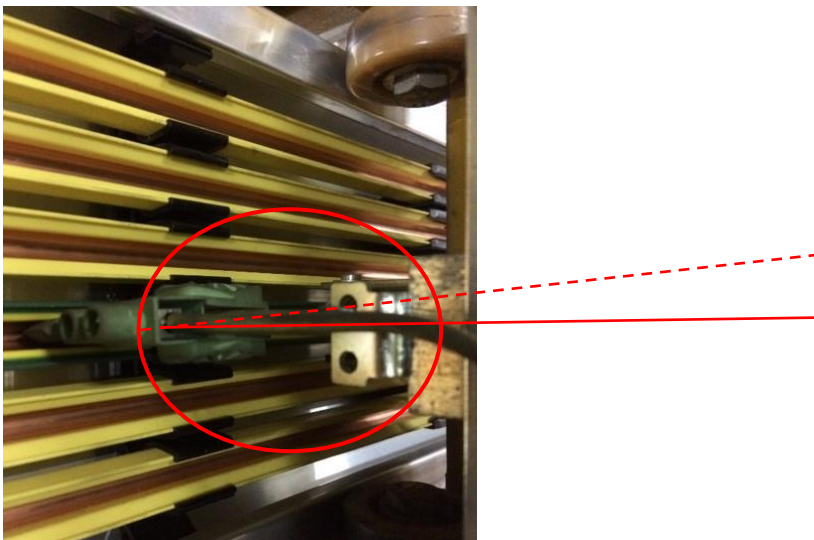
Fig. 6: Collector adjustment

2. Collector adjustment: Brush head not aligned properly (too high!) = Brush head runs permanently in an angle and grinds the plastic isolation of the conductor rail.

- When EMS trolley doors are dismantled (for collector changes) make sure that all doors are marked with numbers (same as trolley numbers) to ensure that combination of doors and trolleys are kept.
- Check all collector support brackets ("Z"-bracket) for exact angles and parallel surface to trolley door and conductor rails.
- Check exact position of door hinges.
- Use proven Conductix-Wampfler high flexible cables.
- Do not bundle cables or use cable marker (negative influence of the collector).
- Check existing brush wear sensor unit (new set up needed).
- Make sure that all PE_{plus} end caps of the conductor rails are green (indication for PE_{plus} system).
